RE: Submittal of Completion Report – Time Critical Removal Action, Lindsay Light II Site/(OU3/North McClurg Court), 341 East Ohio Street, Chicago, Illinois – STS Project No. 1-25585-XJ

**Completion Report  
Time-Critical Removal Action  
Lindsay Light II Site/  
(OU3/North McClurg Court)  
341 East Ohio Street  
Chicago, Illinois**

STS Project No. 1-25585-XJ  
December 31, 2002

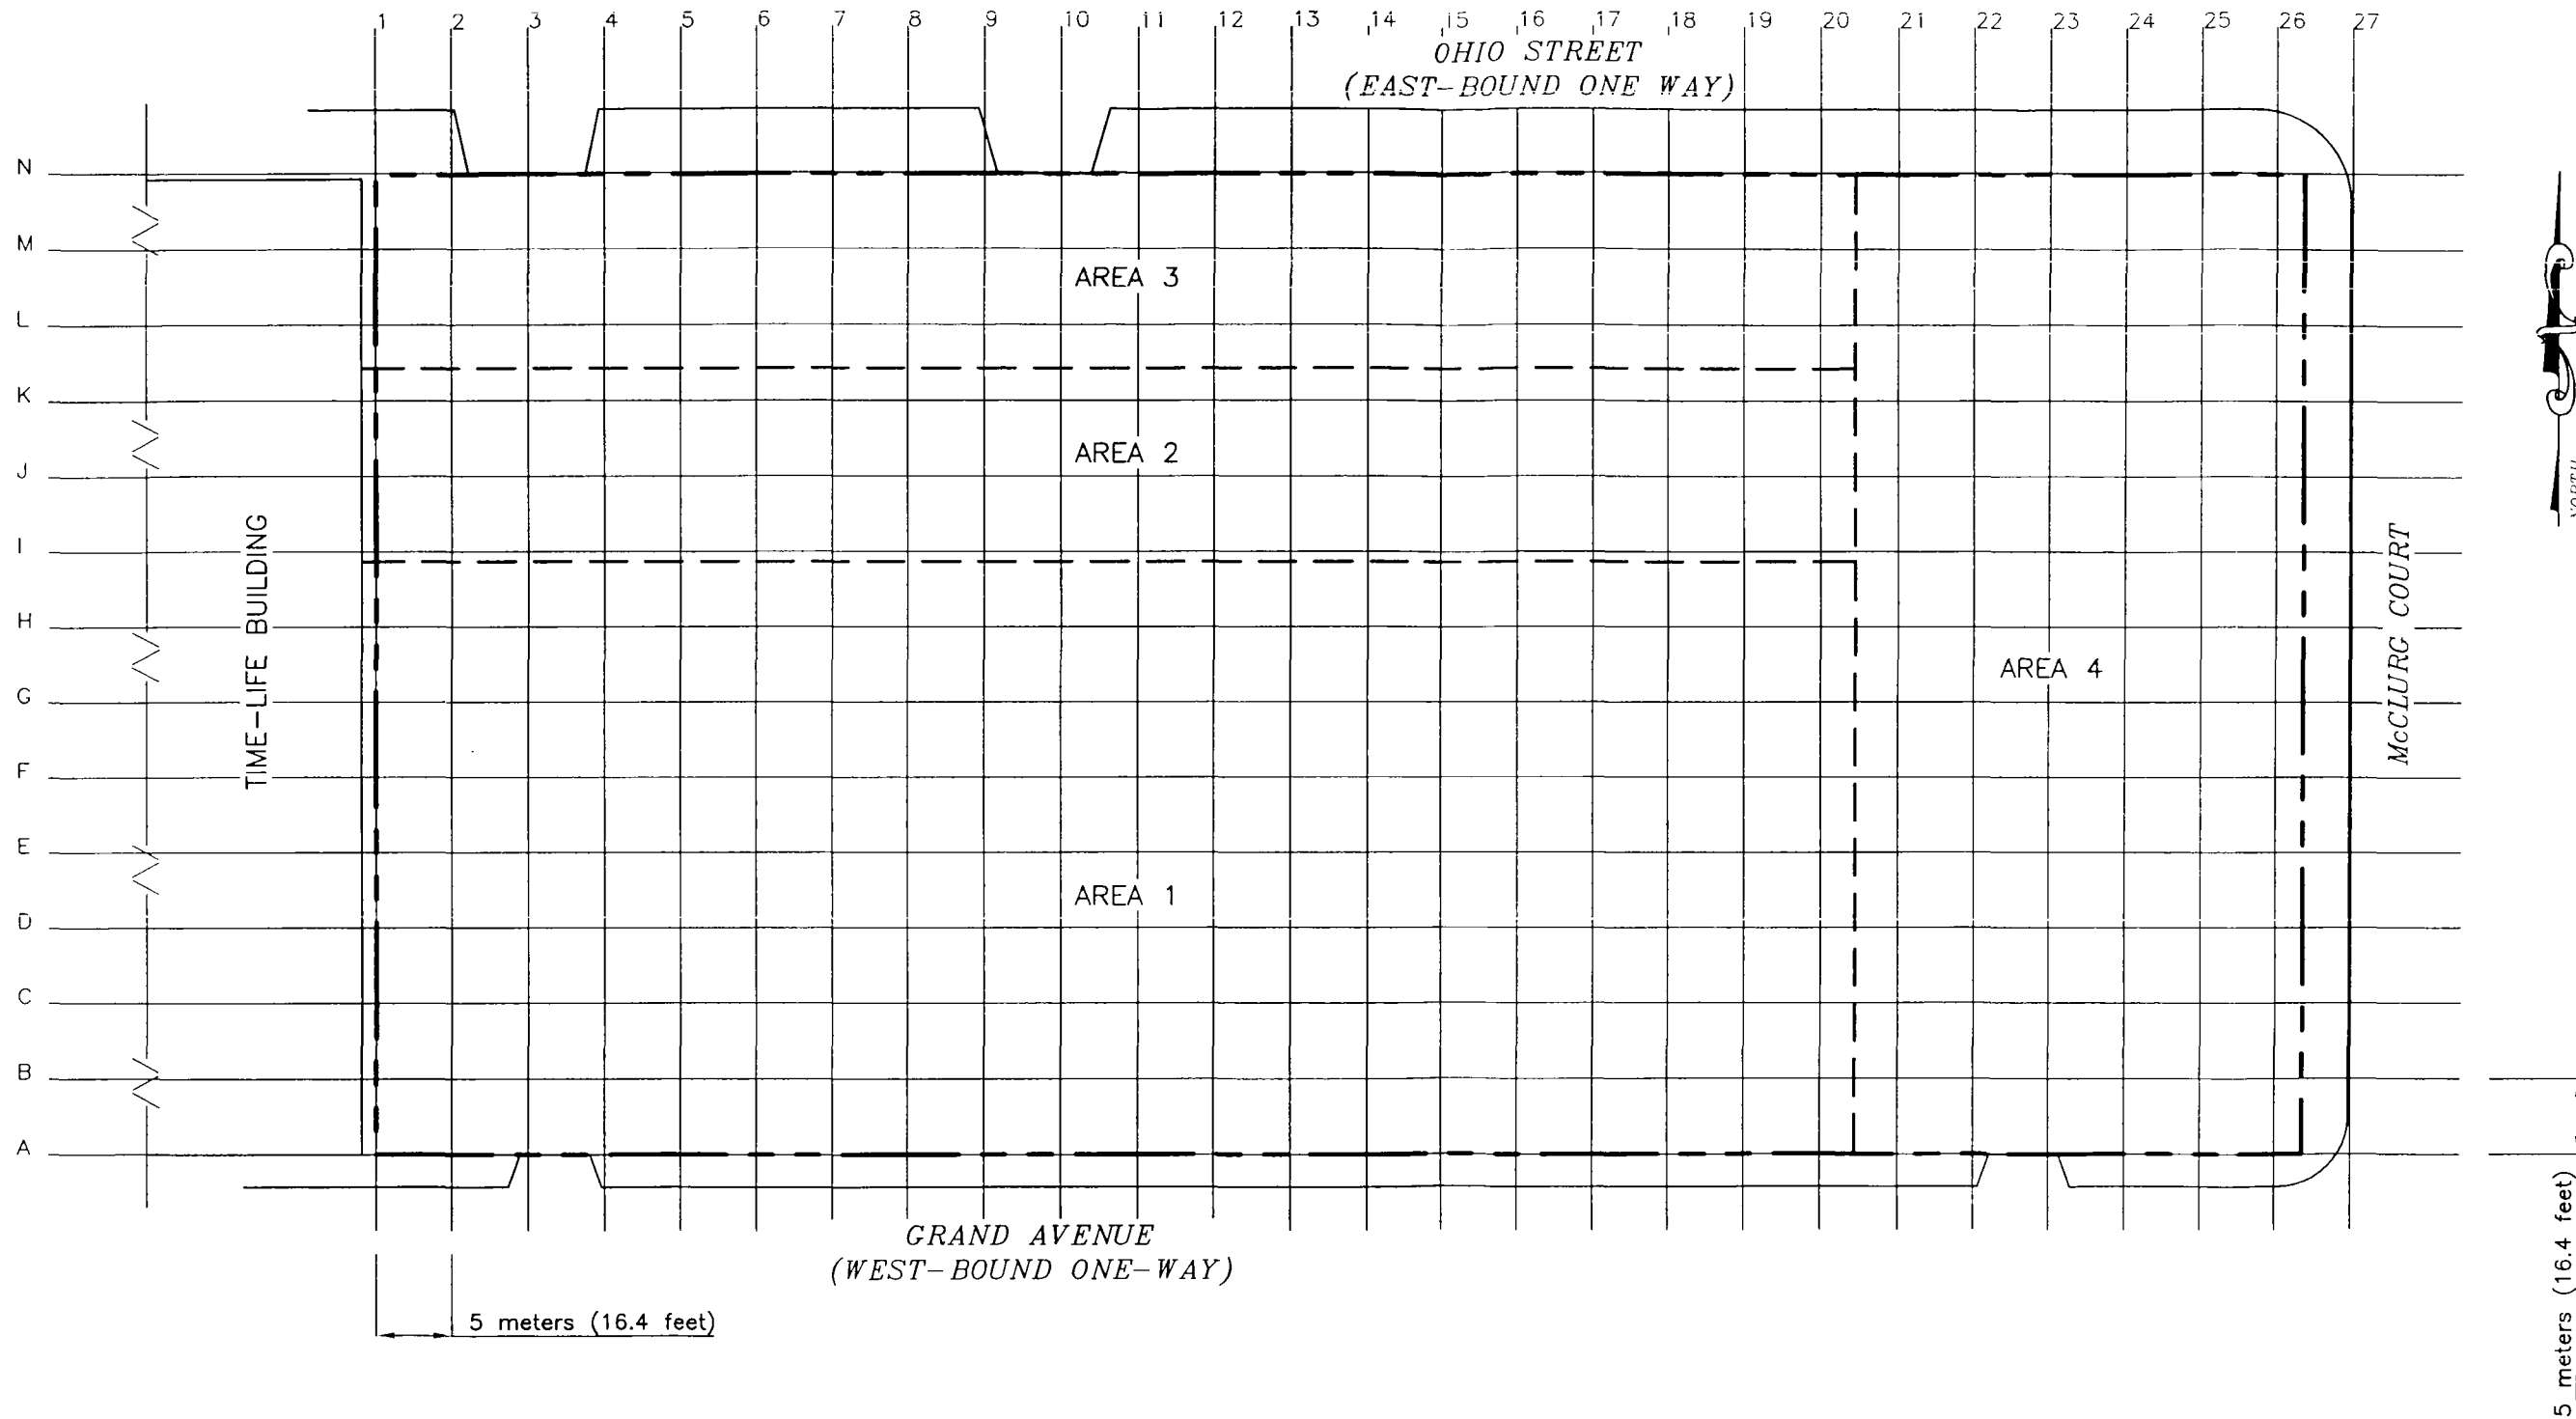
SITE PLAN  
341 E. OHIO STREET SITE  
CHICAGO, ILLINOIS

The Subject Site was sub-divided into a 5-meter by 5-meter grid to aid with guiding and documenting the field work and observations performed pursuant to the Work Plan. Grid boxes were labeled A to N from south to north and 1 to 27 from west to east. Grid A-1 was in the southwest corner of the Subject Site and Grid N-27 was located at the northeast corner of the Subject Site. Figure 2 presents a site plan showing such grid on the Subject Site.

The excavation work for the Removal Action progressed across the Subject Site in a phased manner. Figure 2 shows how the Subject Site was divided into Areas 1, 2, 3 and 4 pursuant to the Work Plan. Removal activities were to be performed in several phases sequentially over these four Areas. Area 1 included what was anticipated to be the largest quantity of impacted material, based on the previous investigations. It was proposed that, following that removal effort, the remaining Areas, 2, 3 and 4, would be remediated of identified impacts. The proposed sequence of removal was planned to facilitate traffic on the Subject Site as larger and larger areas were disrupted.

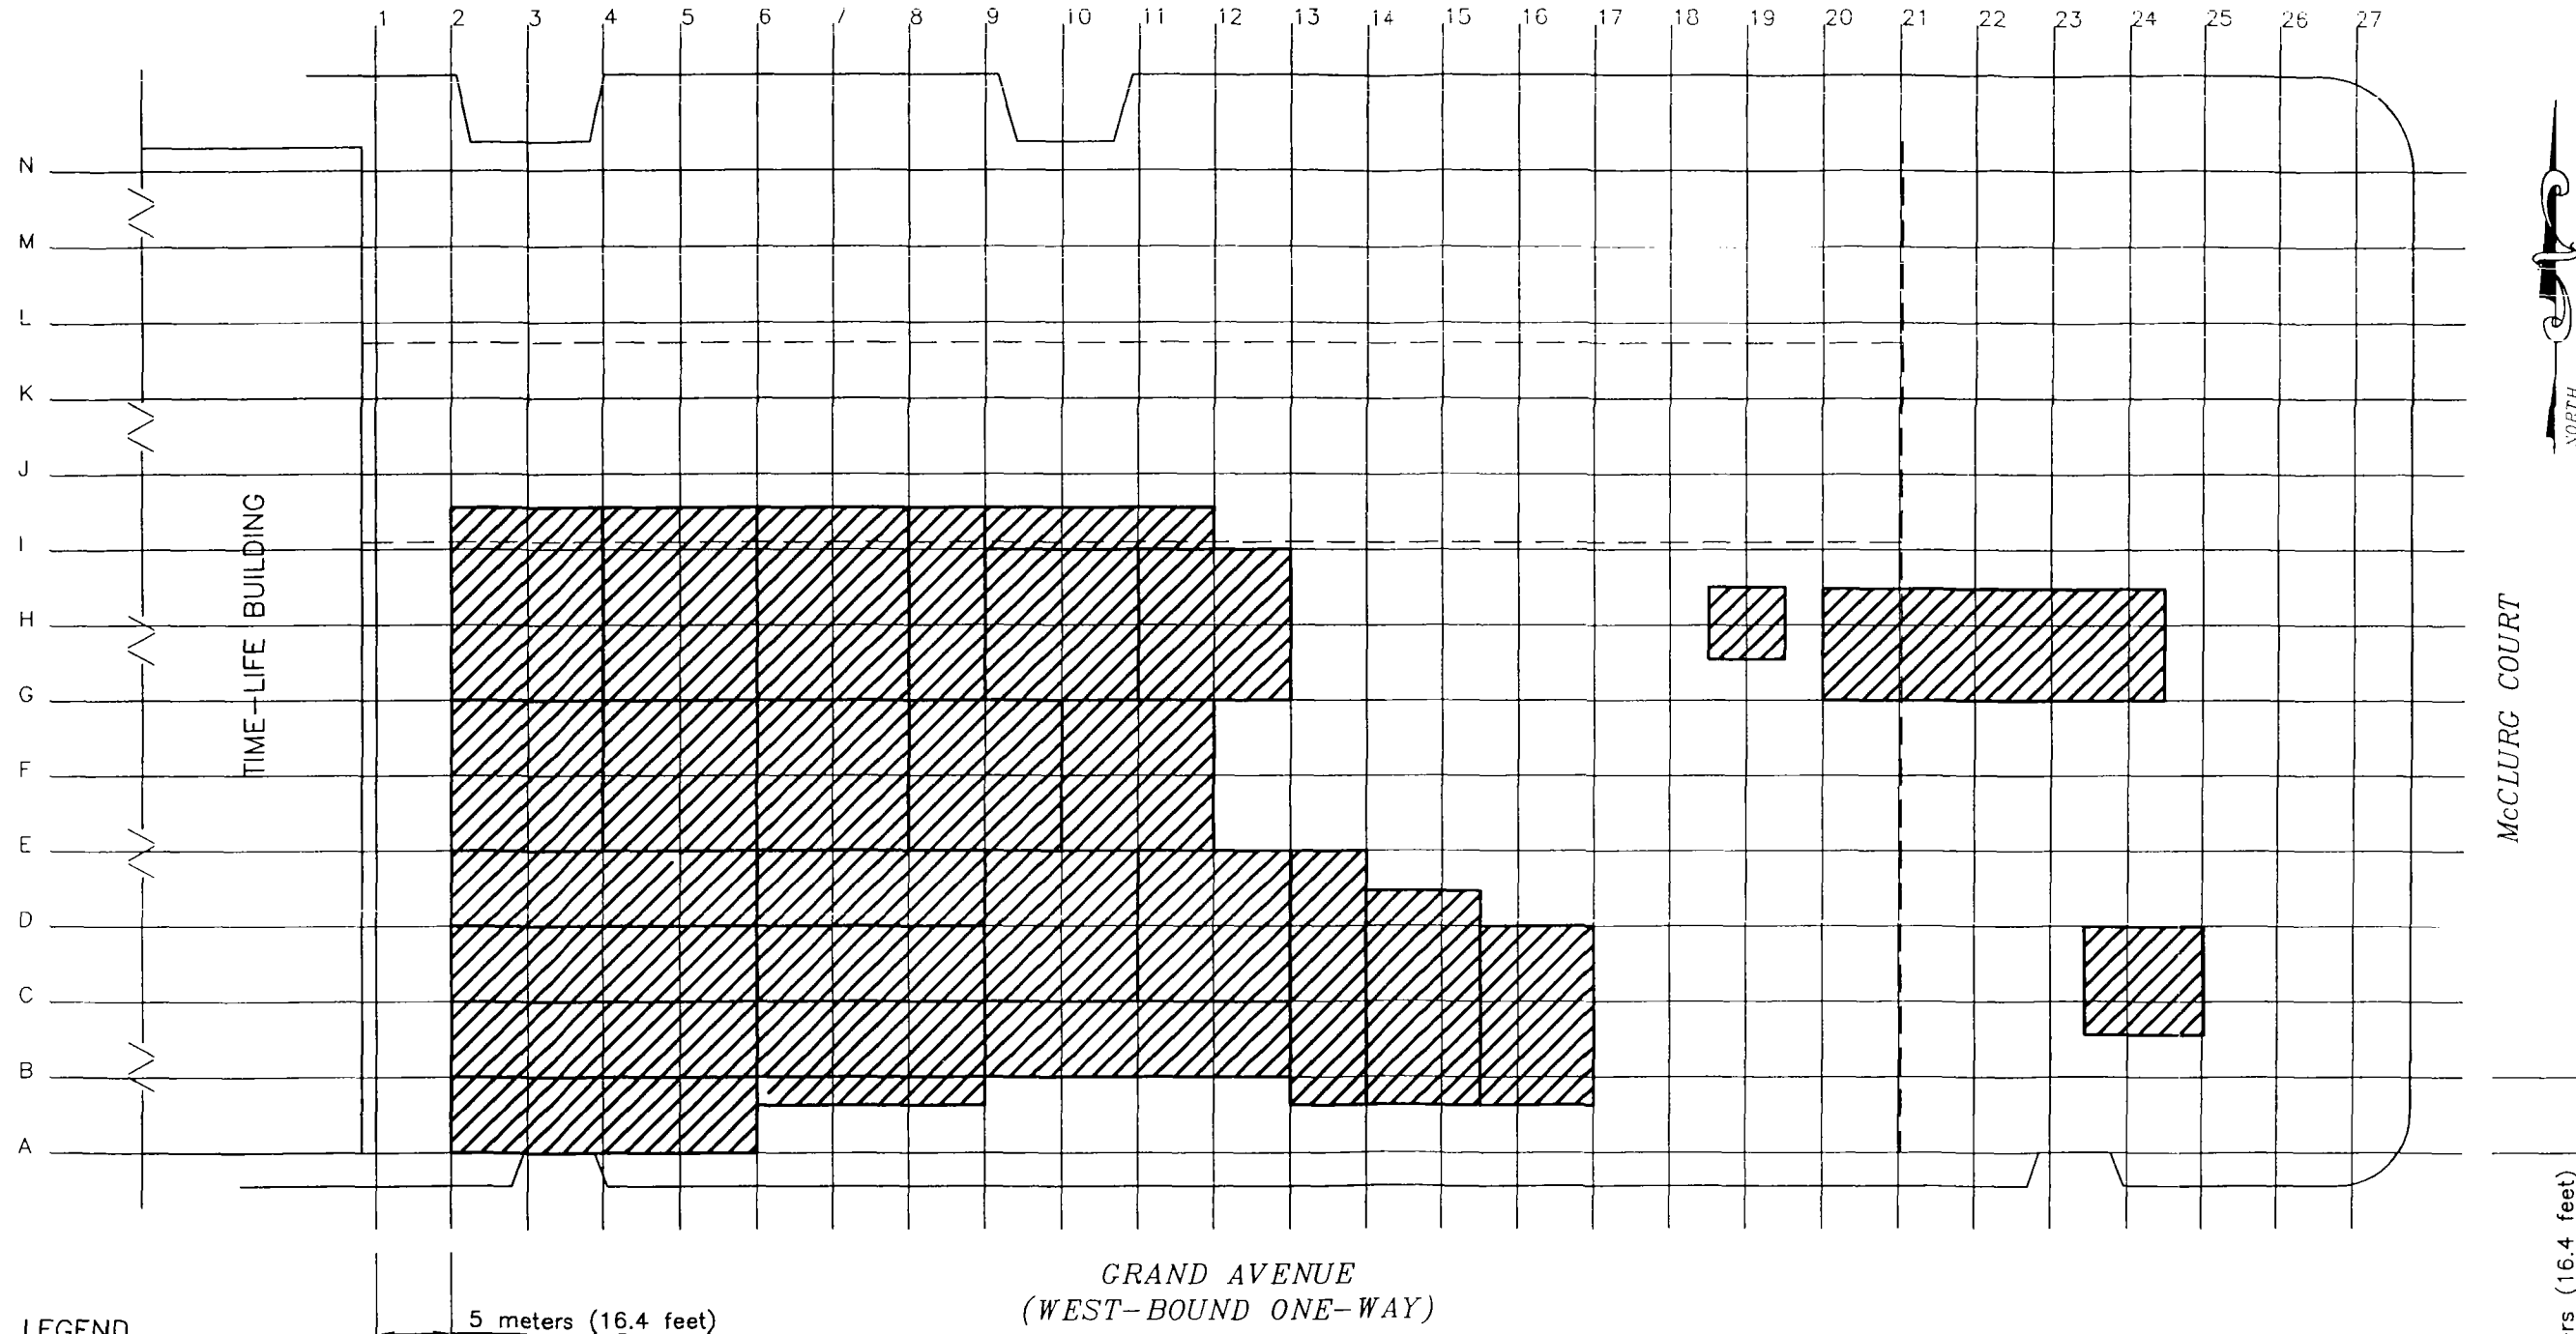
STS PROJECT NO.  
25585-XI  
STS PROJECT FILE  
GG-125585-XI\_5.dwg  
SCALE  
AS SHOWN  
FIGURE NO.  
5

At each location where radiologically-impacted material was removed, an exclusion zone was established. Verification of removal under Phase I was required for every exclusion zone. Figure 5 documents the locations for the Phase I exclusion zones identified, remediated, and for which verification sign-off was received from USEPA.

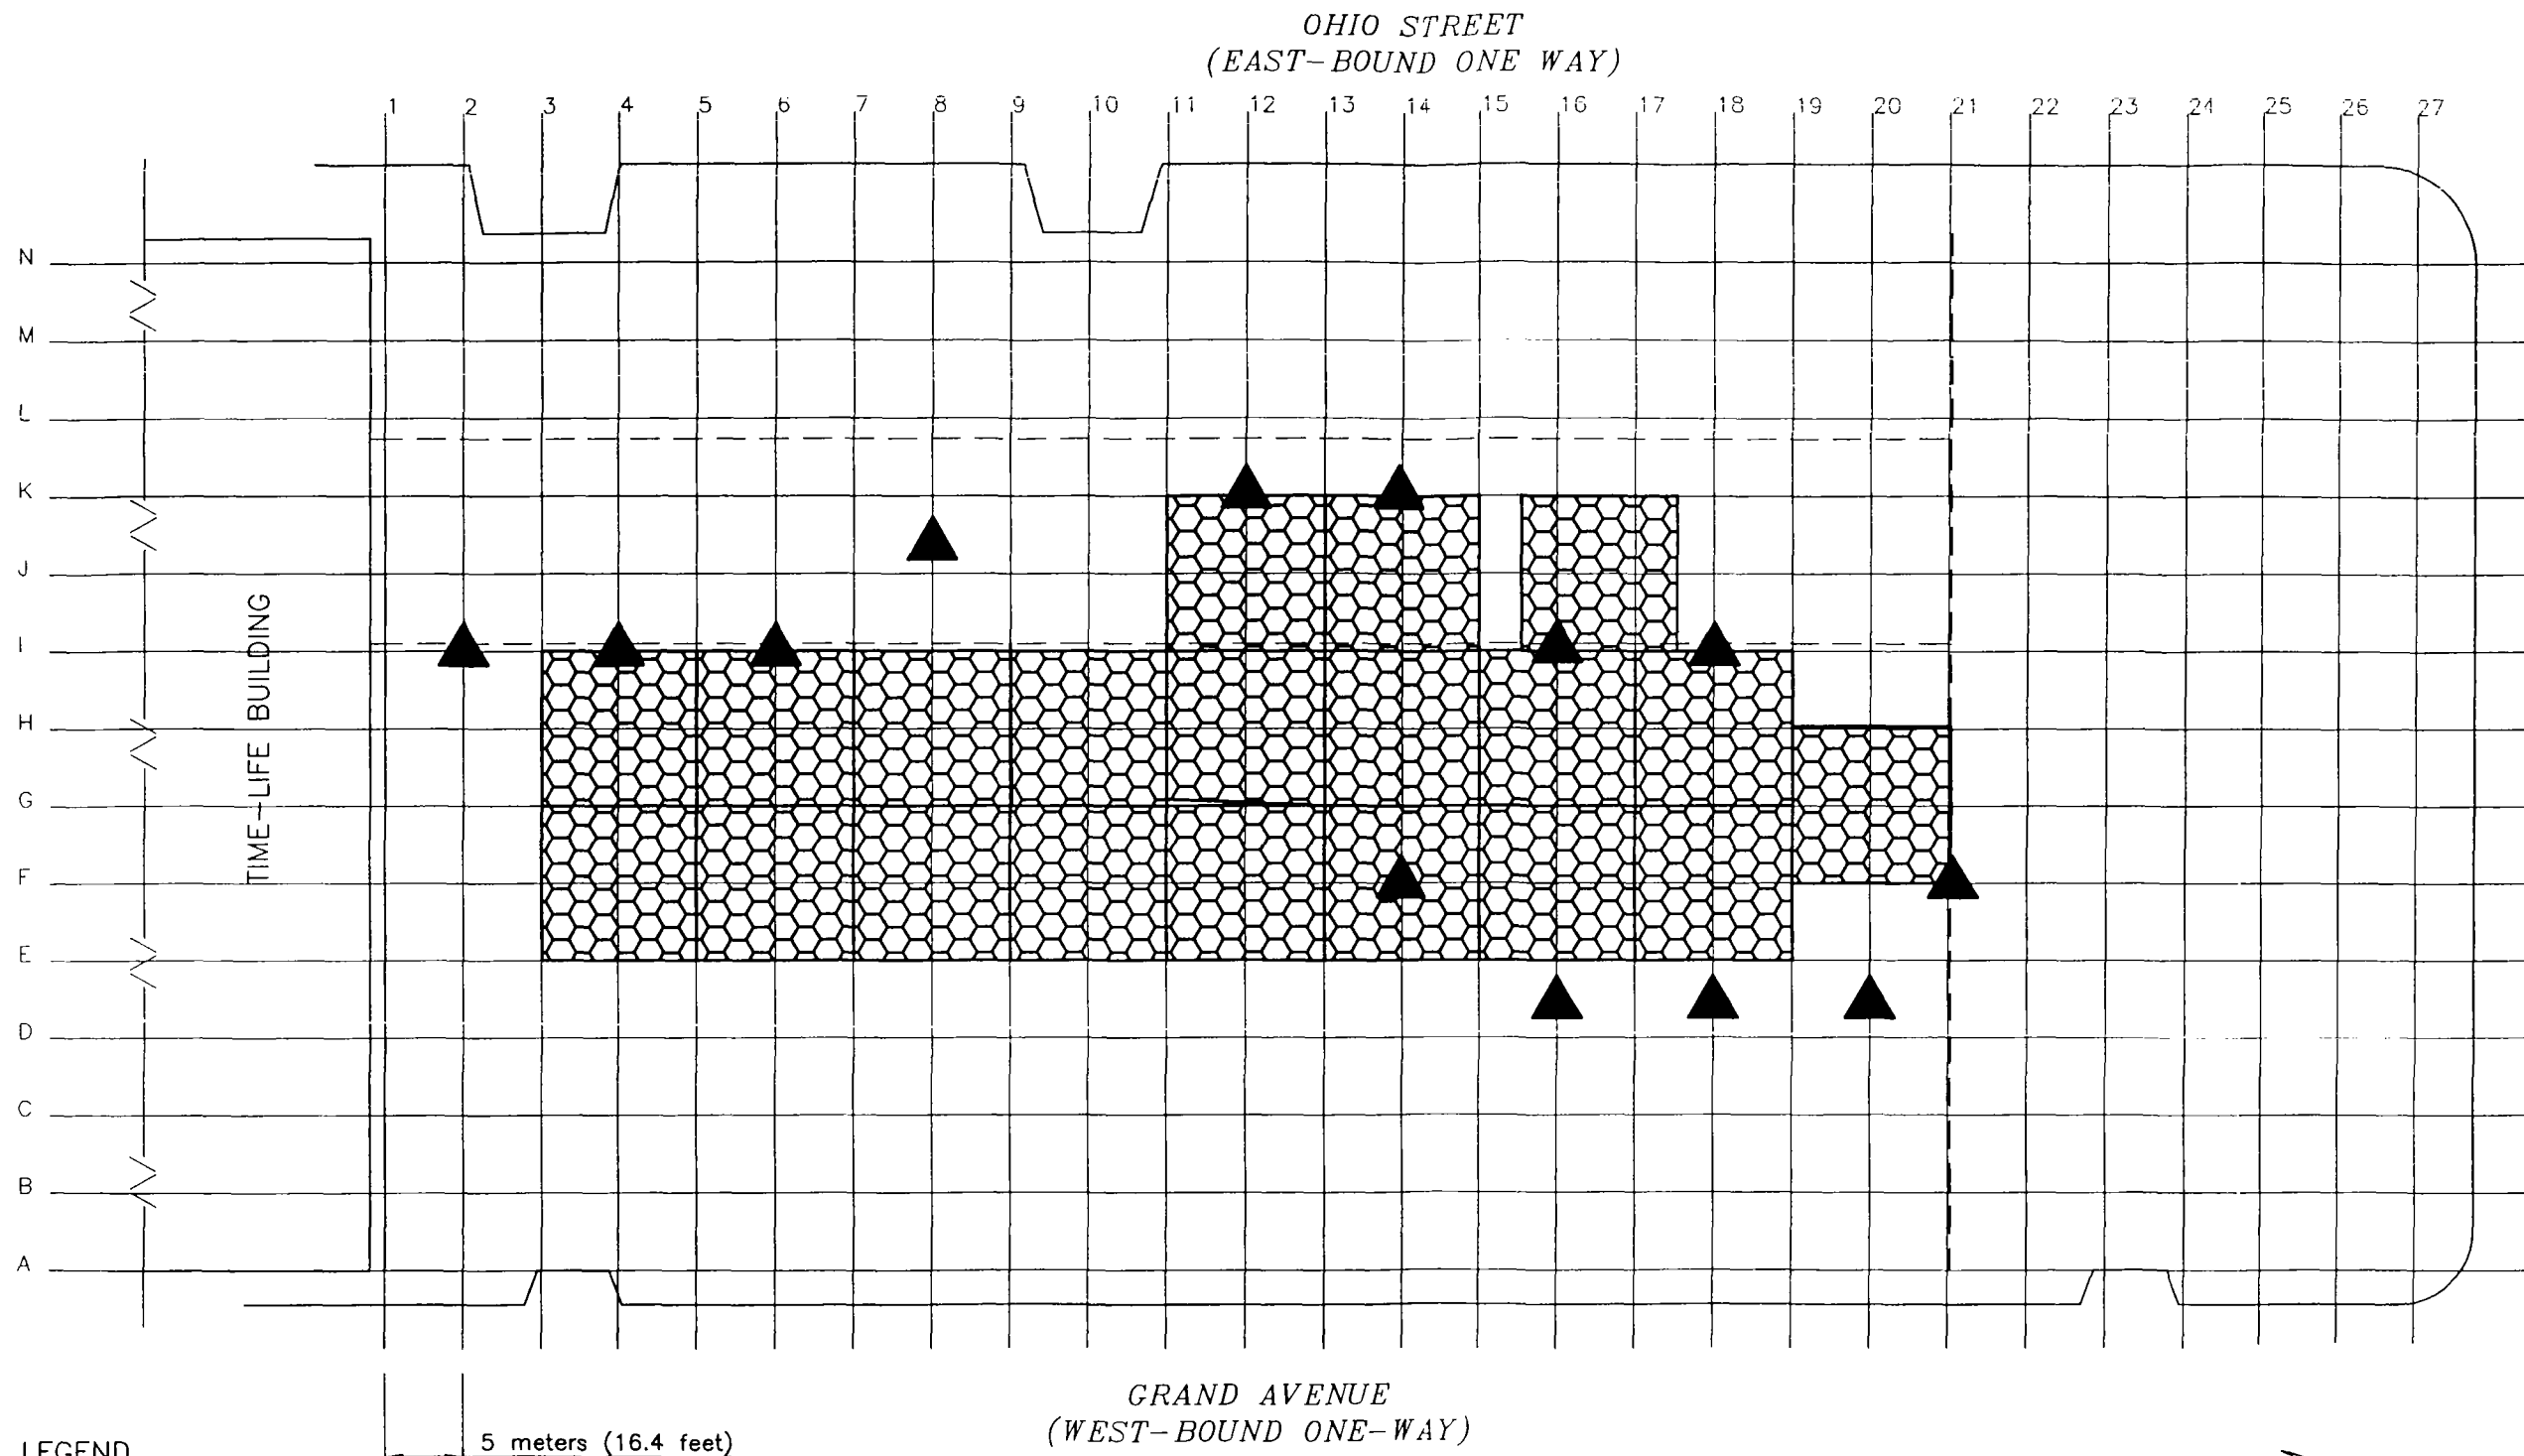
Pesticide-impacted materials were removed initially from the areas found to be impacted by pesticides evident in the field testing. Field tests were conducted using immunoassay test kits (Enviroguard) at the locations shown on Figure 6. The test kits were set up to provide a measurement of whether the pesticide concentration was above or below the cleanup threshold. Note the cleanup threshold included values for a variety of pesticide compounds detected at the Subject Site. The immunoassay test results did not determine individual pesticide concentrations but a range of compounds characteristic of the chlordane group of pesticides. As a general threshold, the cleanup standard for the field tests was set at 1.8 parts per million, chlordane, which is the Illinois Environmental Protection Agency's Tiered Approach to Corrective Action Objectives (TACO) Tier 1 Residential limit for soil ingestion for chlordane.

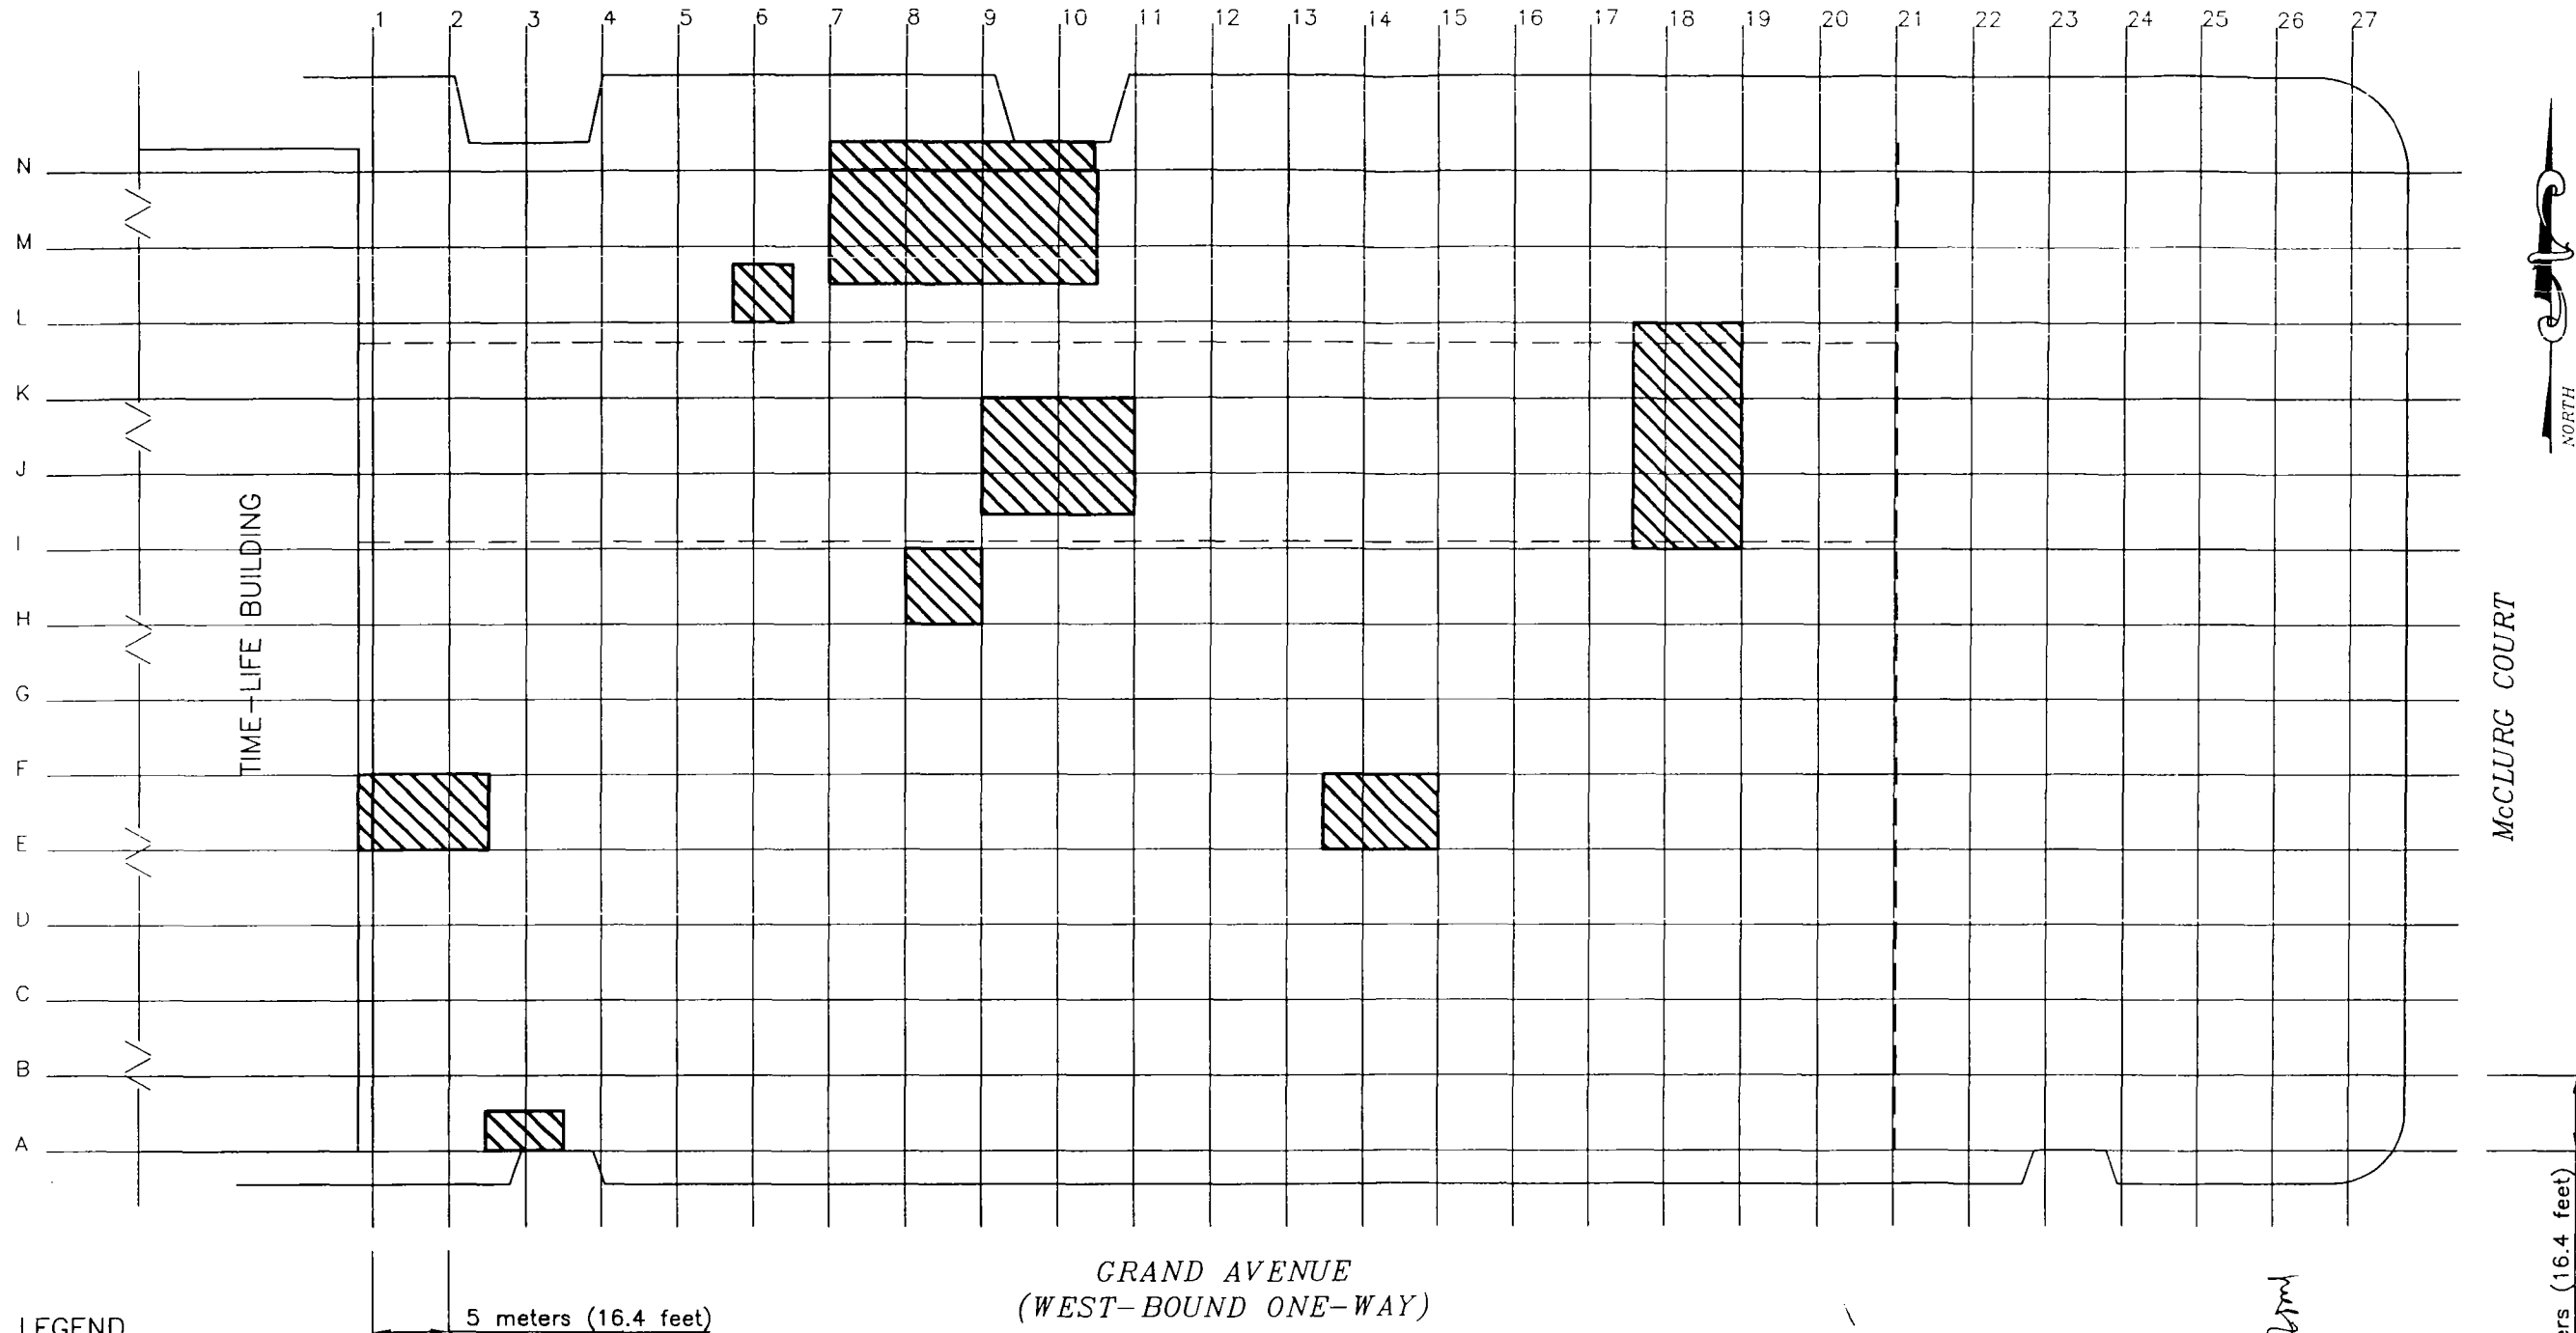
Locations where material exceeding the 7.1 pCi/g clean-up level was encountered during the Phase II excavation and screening were designated exclusion zones. USEPA verification was required to document clean-up in each such exclusion zone. Figure 7 shows the locations of the Phase II exclusion zones.

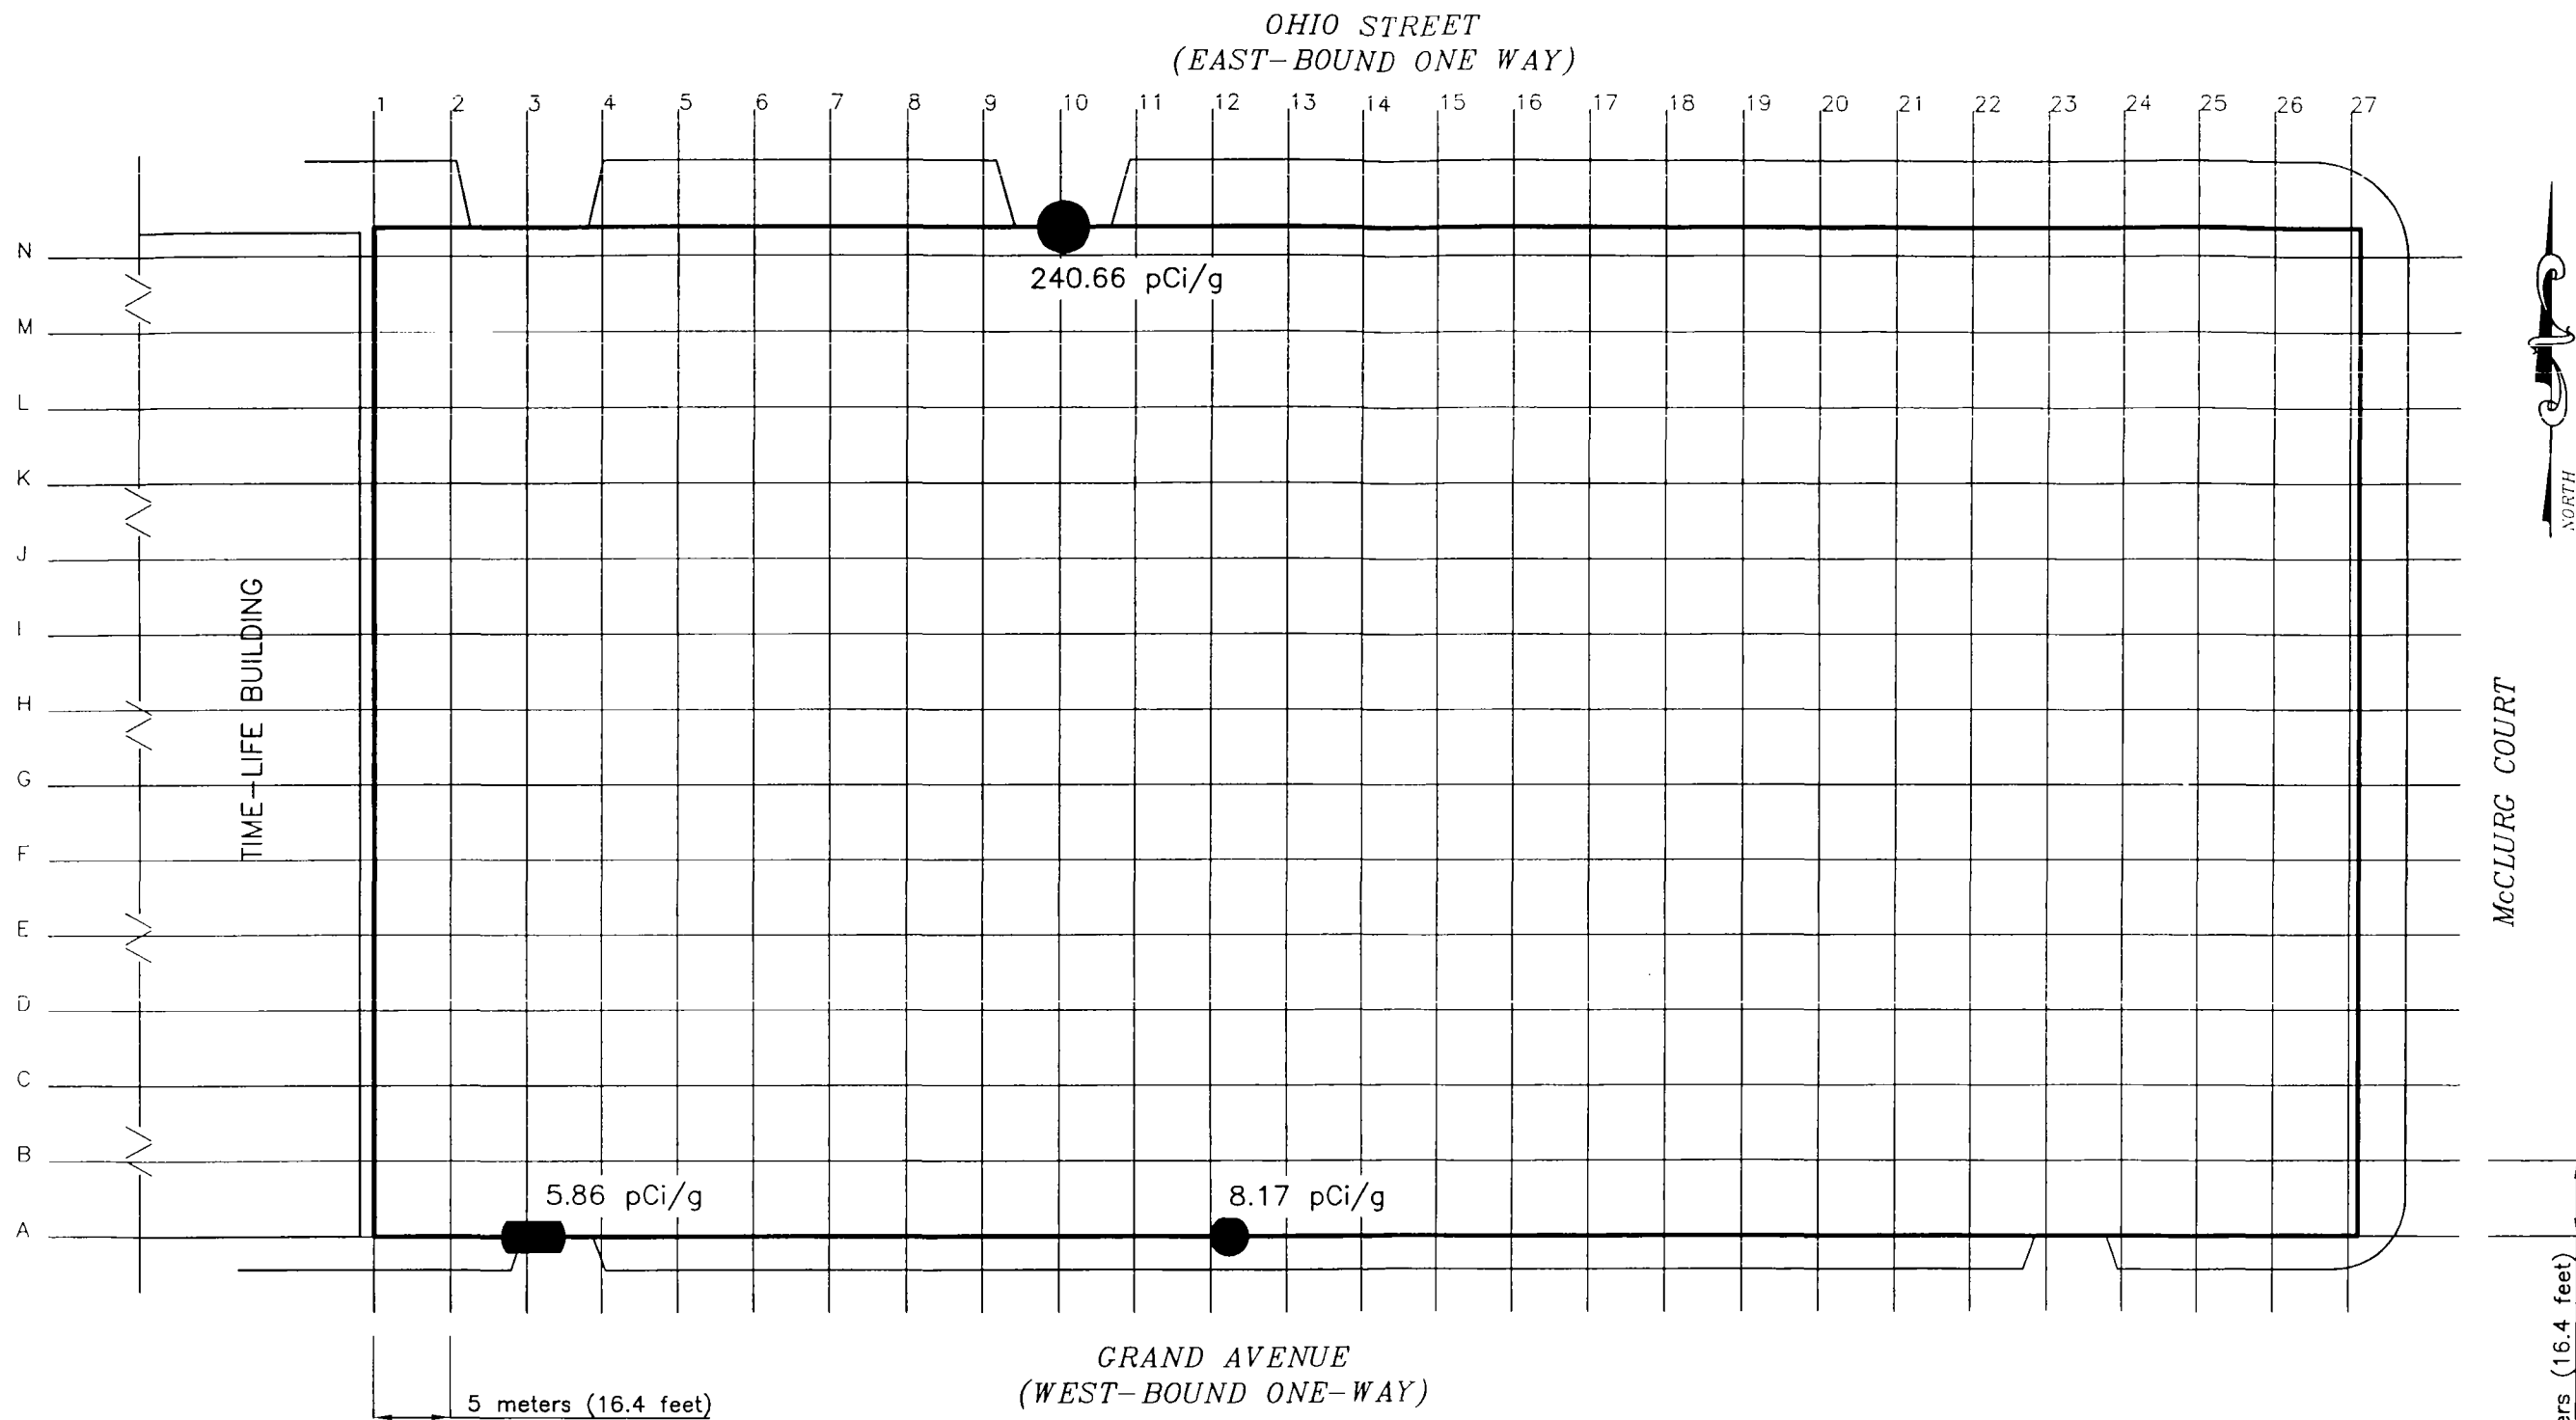
STS Consultants Ltd. Consulting Engineers			
STS PROJECT NO. 25585-XI			
STS PROJECT FILE GG-125585-XI_09.dwg			
SCALE AS SHOWN			
FIGURE NO. 9

8.17 pCi/g

LOCATION OF RADIOLOGICALLY IMPACTED MATERIAL REMAINING BENEATH THE ADJACENT SIDEWALK. NUTRANL ANALYTICAL RESULTS.

The excavation work resulted in removing all radiologically-impacted material from within the limits of the Subject Site. Several locations were cleaned to the property line with material noted in the excavation sidewall extending underneath the adjacent sidewalk. Figure 9 shows the locations for material off-site under the sidewalk. Analytical results for samples obtained from those locations are included in Appendix G.

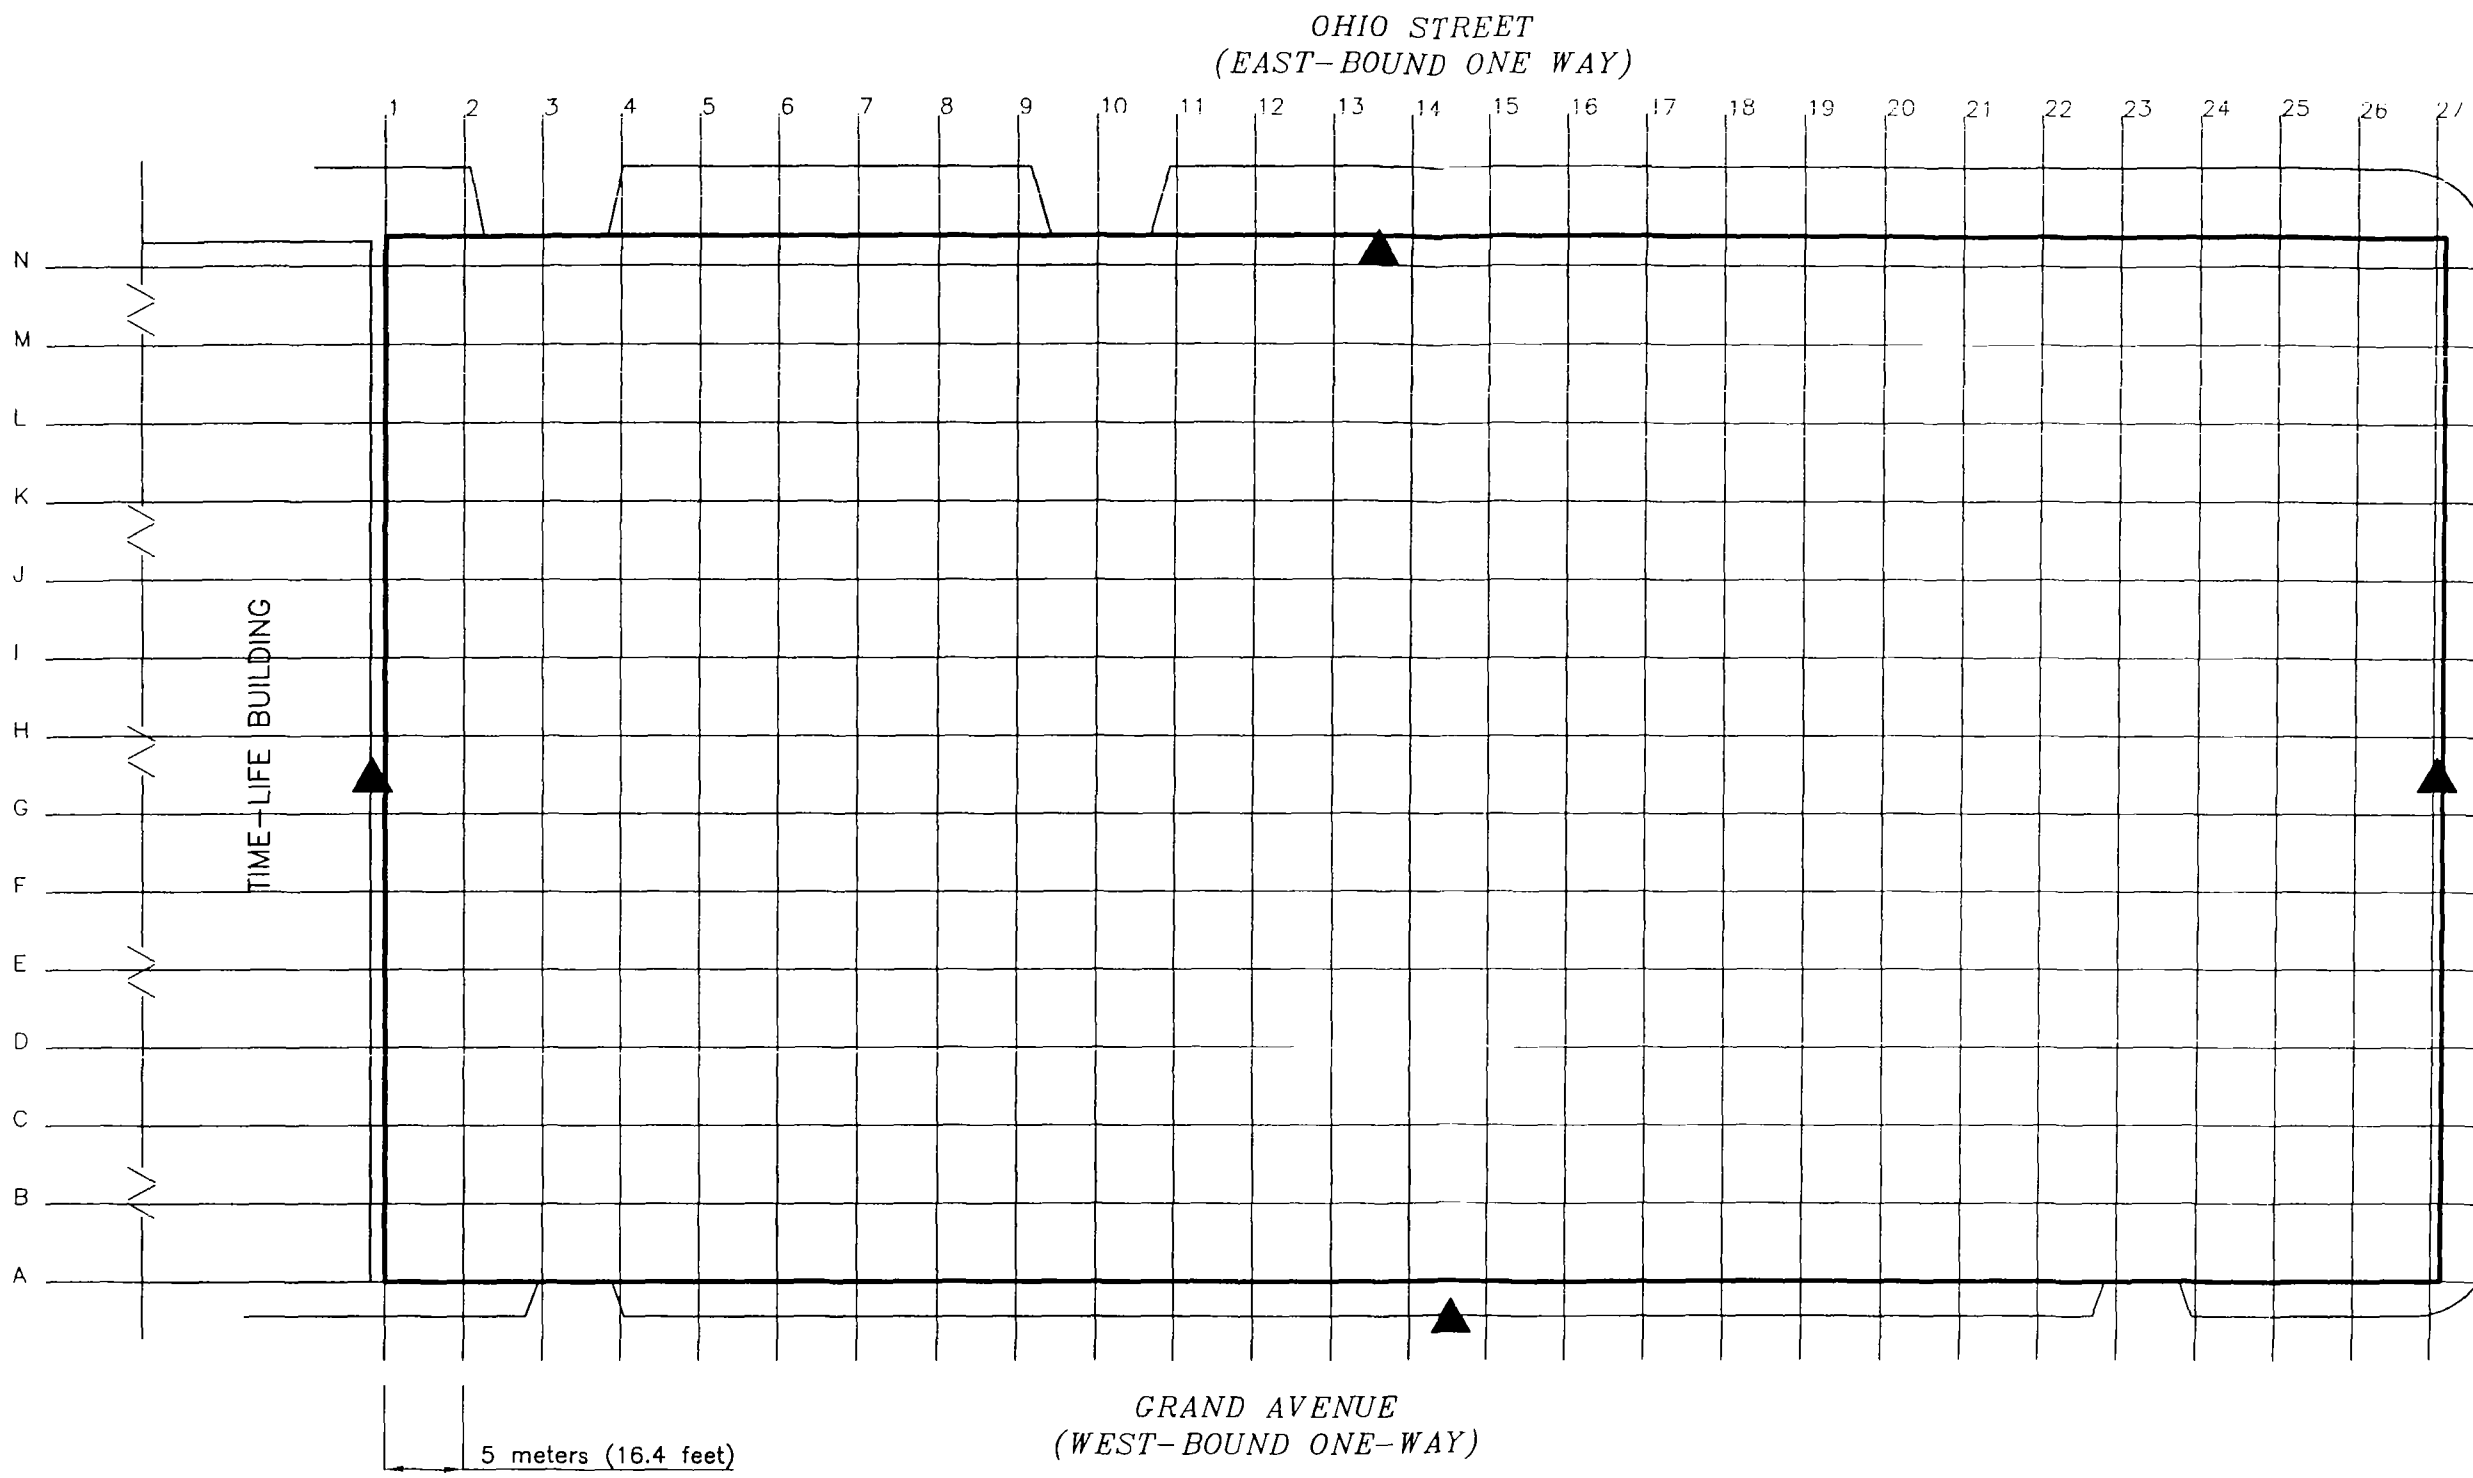
<b>AIR MONITORING LOCATIONS</b> <b>341 E. OHIO STREET PROJECT</b> <b>CHICAGO, ILLINOIS</b>		DRAWN BY	HRS	DATE	12/30/02
		CHECKED BY	JRA	DATE	12/30/02
		APPROVED BY	RGB	DATE	12/30/02

▲ PERIMETER AIR MONITORING LOCATIONS

The air samples were analyzed the day after collection and again after four days to allow for short lived daughters to decay. No exceedances of the exposure limit for the site perimeter of 30% of the Derived Air Concentration (DAC) were documented for any day of operation. Perimeter air monitoring results are provided in Appendix J.
